CONSTRUCTION SUPERVISION OF THE ASPARA-BLAGOVESHENKA
SECTION IN ZHAMBYL OBLAST, INVESTMENT PROGRAM PROJECT4
(ADB Loan # L2735-KAZ, CAREC Transport Corridor I)

BIANNUAL ENVIRONMENTAL MONITORING REPORT - January 2014

Bi-annual Environmental Monitoring Report

Project Number: 41121-053
{January 2014}

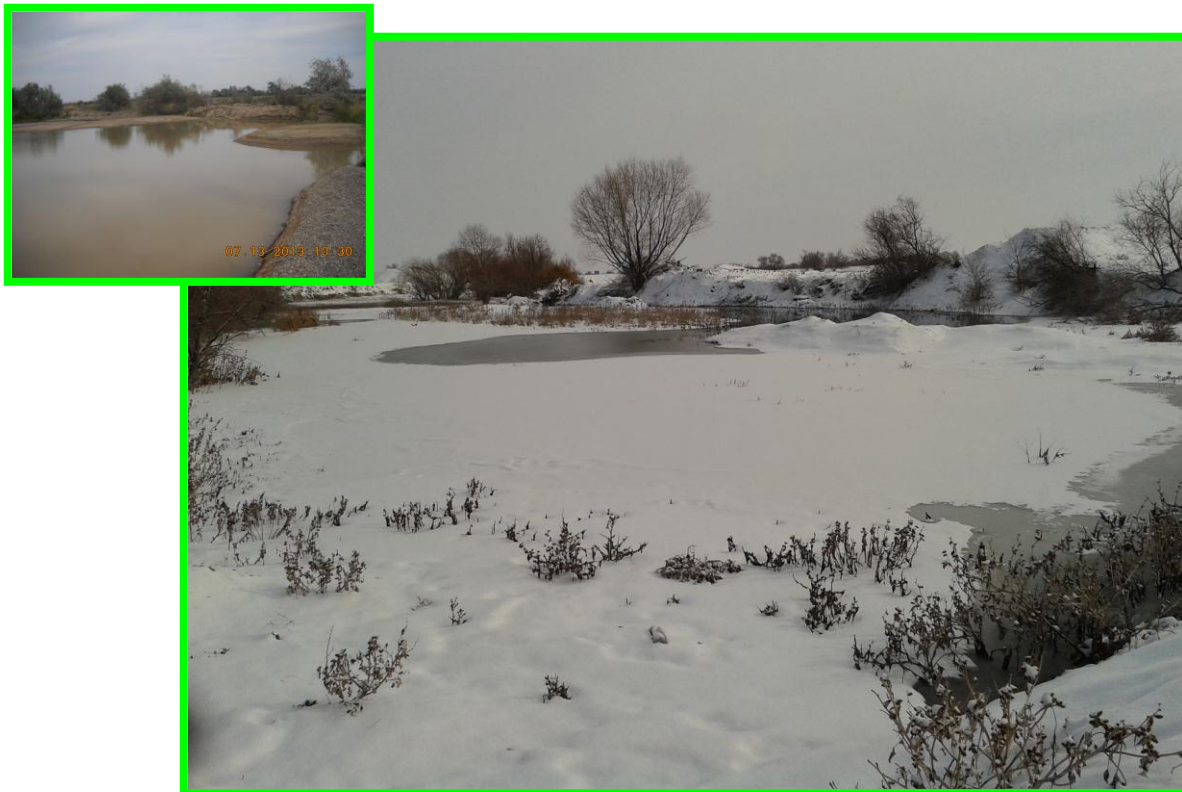
Photo No. 1 : Formerly washing water containment pond

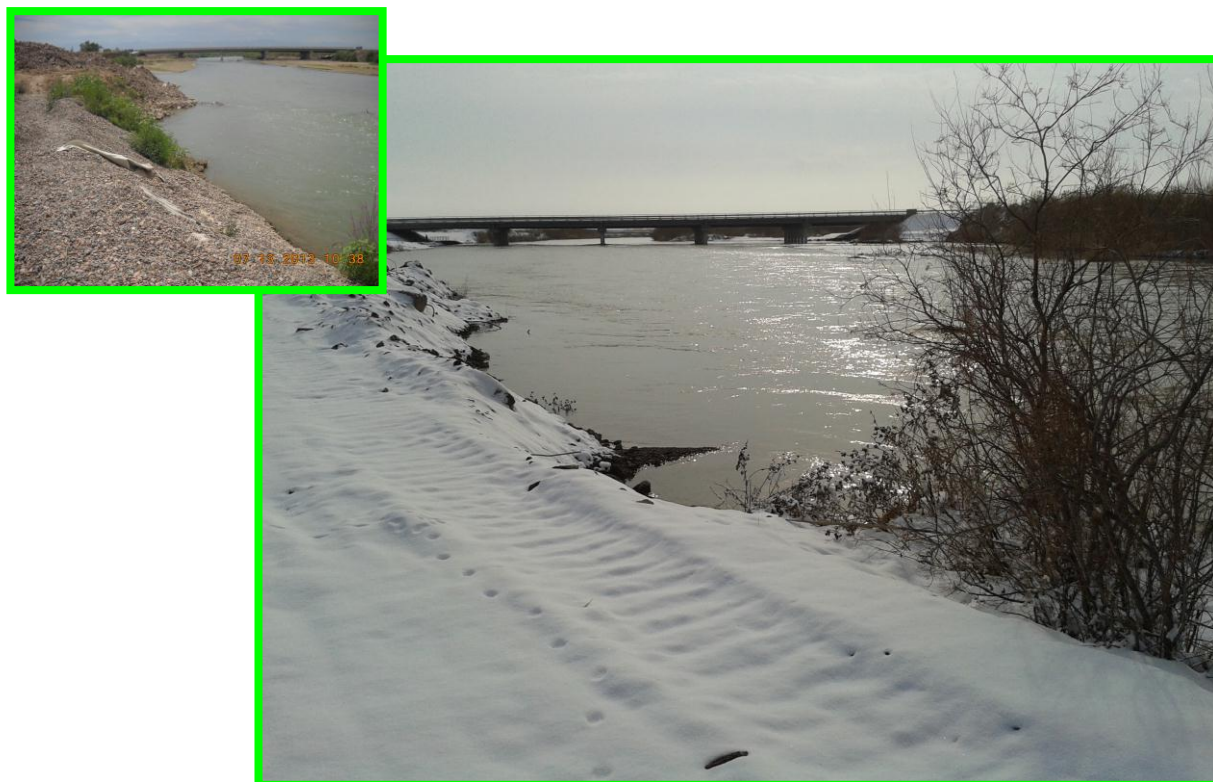
Photo No. 2 : Siltation pond berm Vicinities of Shu River

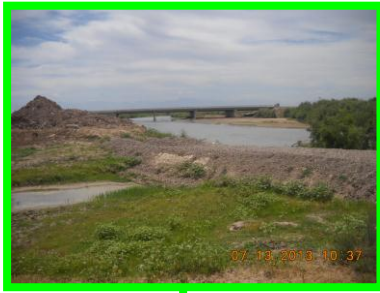
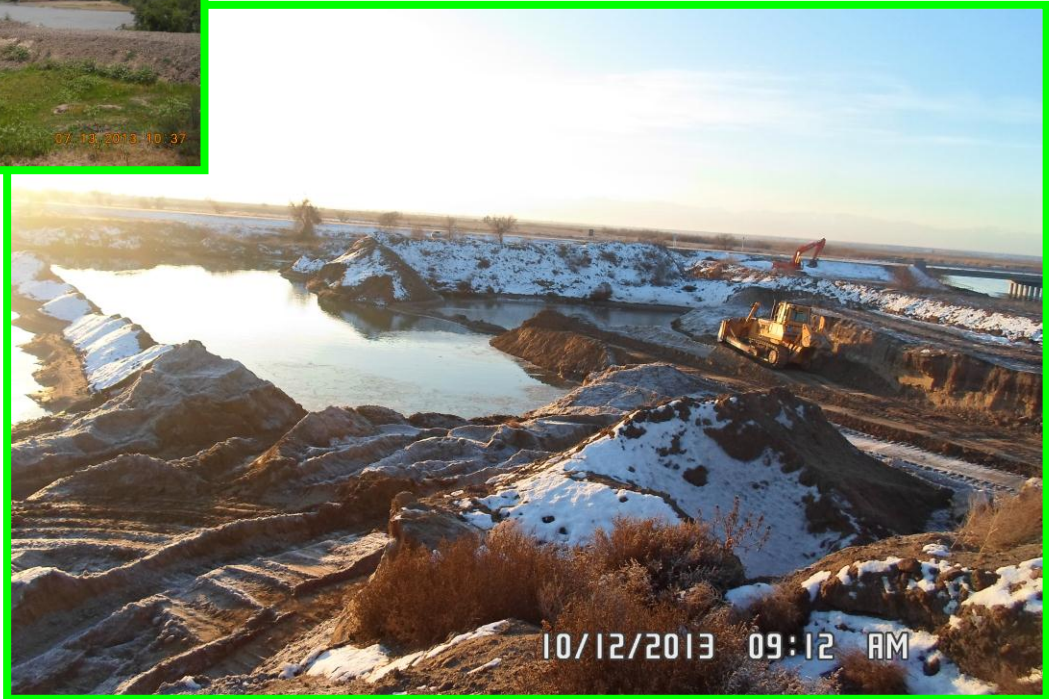
Photo No. 3 : Restoration of sand and gravel area was started

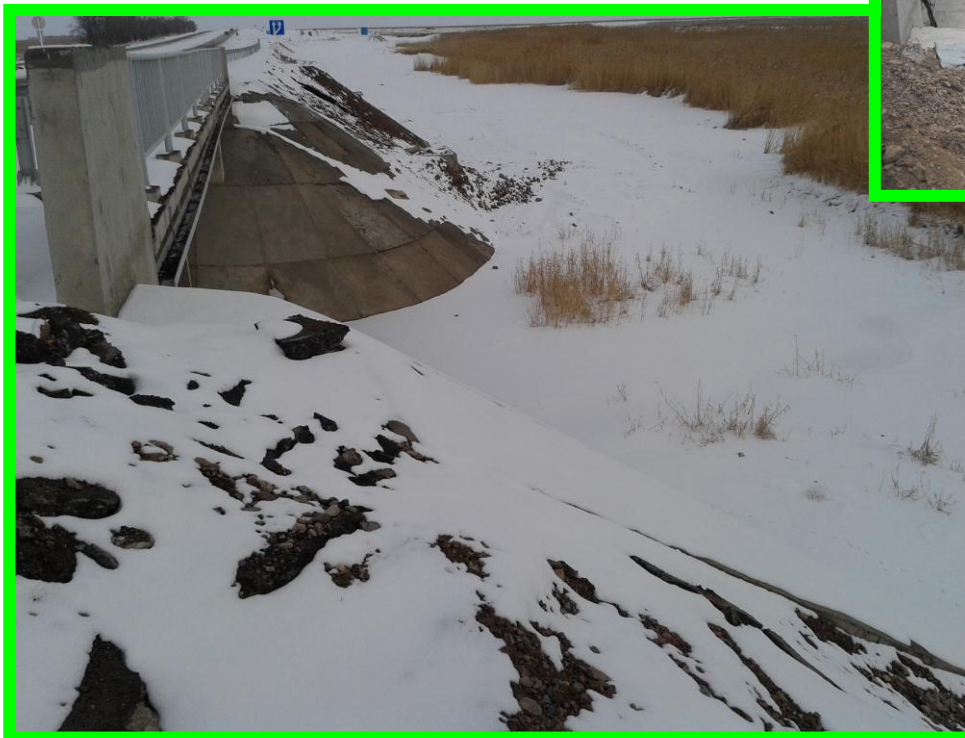
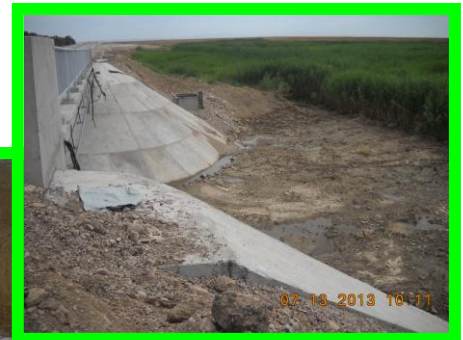
Photo No. 4 : Flow of Shorgo River has to be inspected

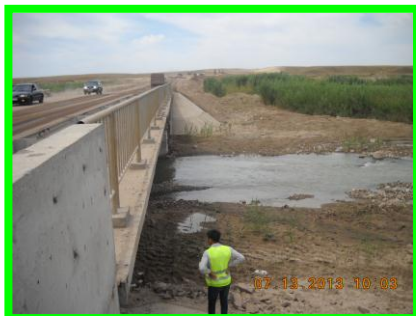
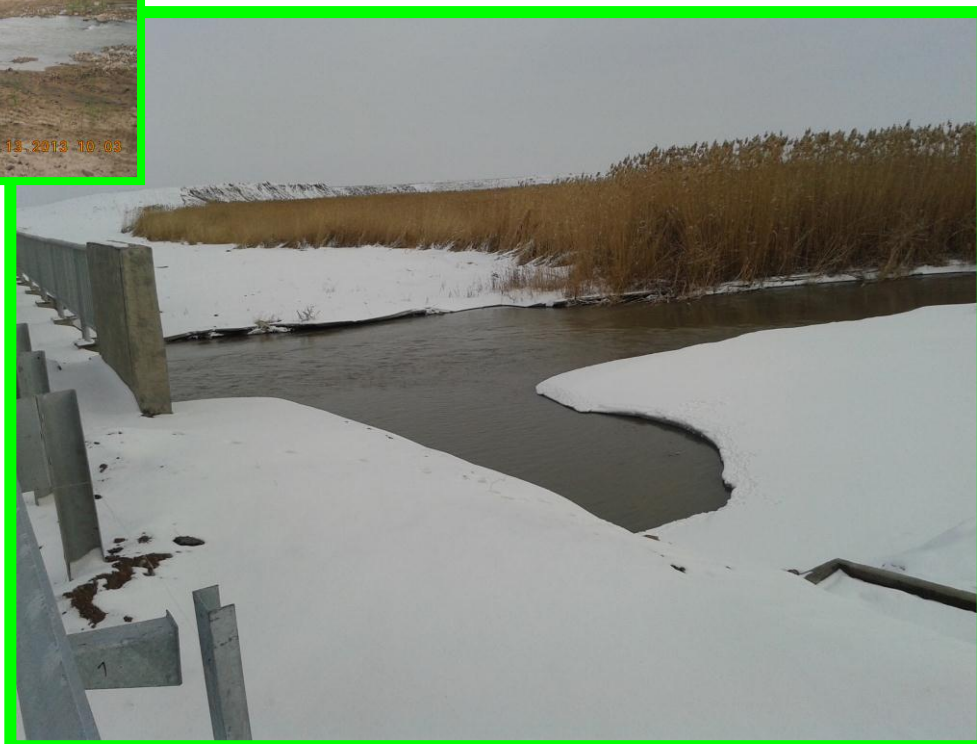
Photo No. 5 : Need to inspect the slope of Aksu River

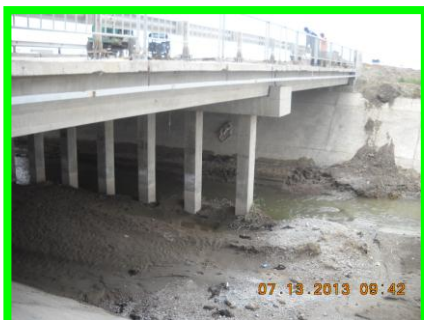
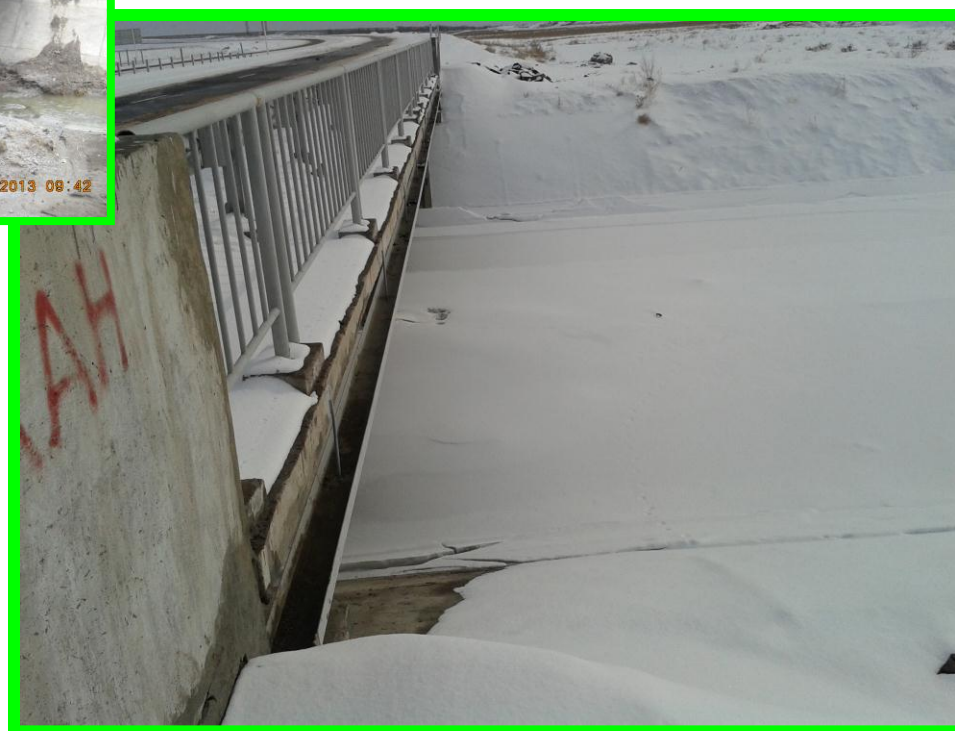
Photo No. 6 : Vicinities of Karabalta River

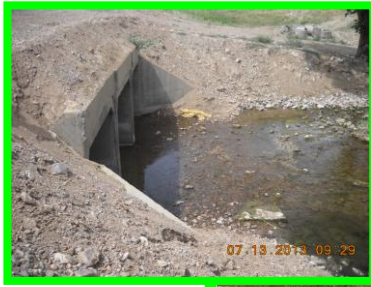
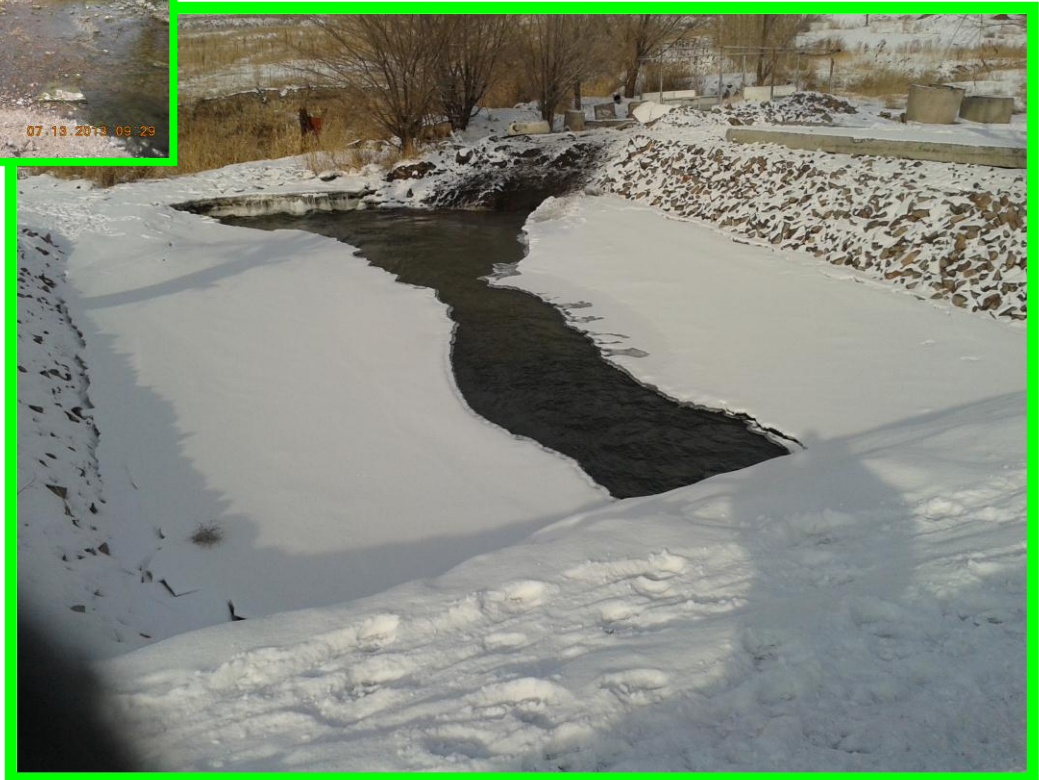
Photo No. 7 : Vicinities of Box culvert at km 296+400

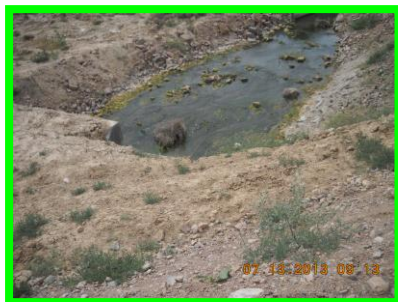
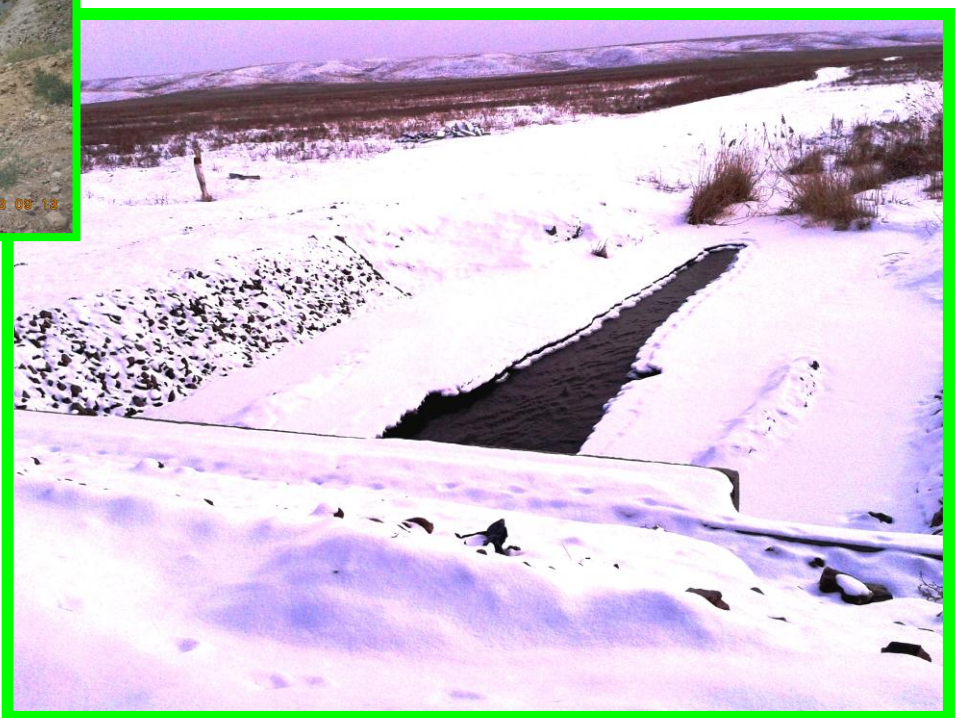
Photo No. 8 : Vicinities of Box culvert at km 306+602

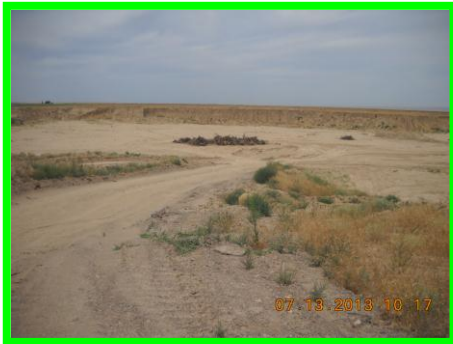
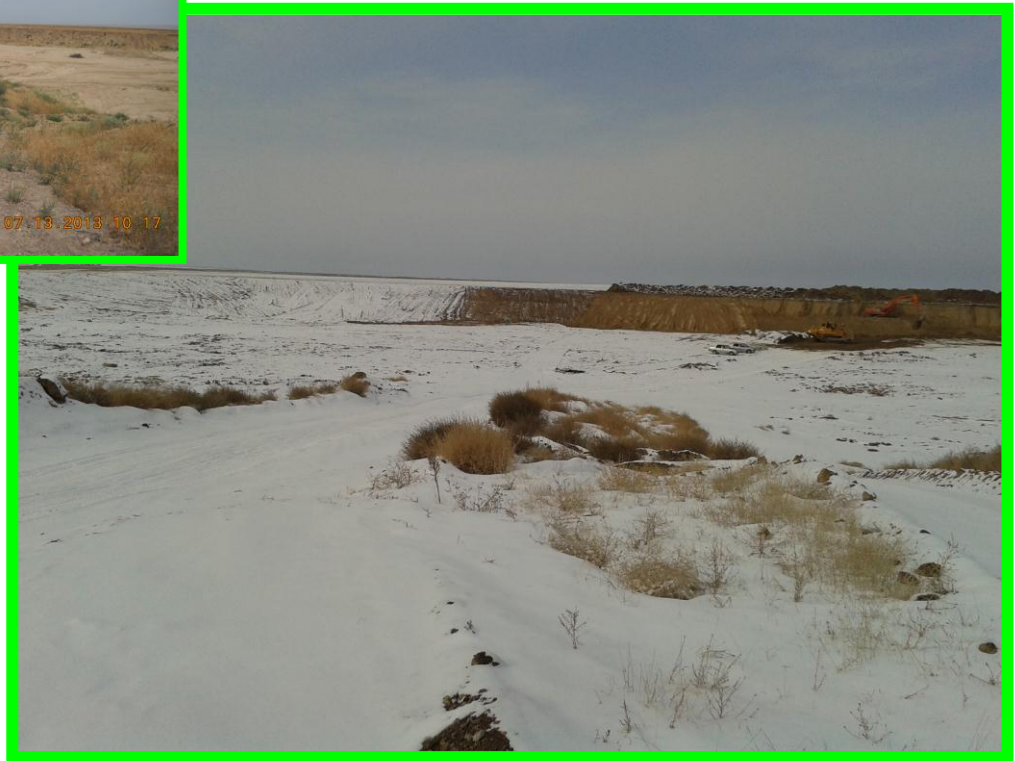
Photo No. 9 : Initial reinstatement of borrow pit at km 269+500 (Right Hand Side)

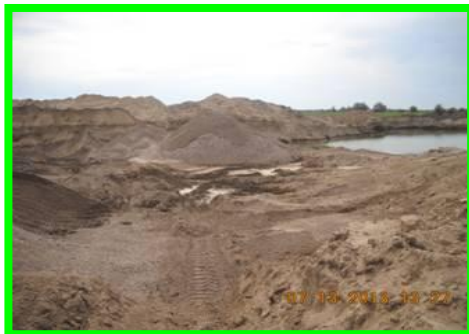
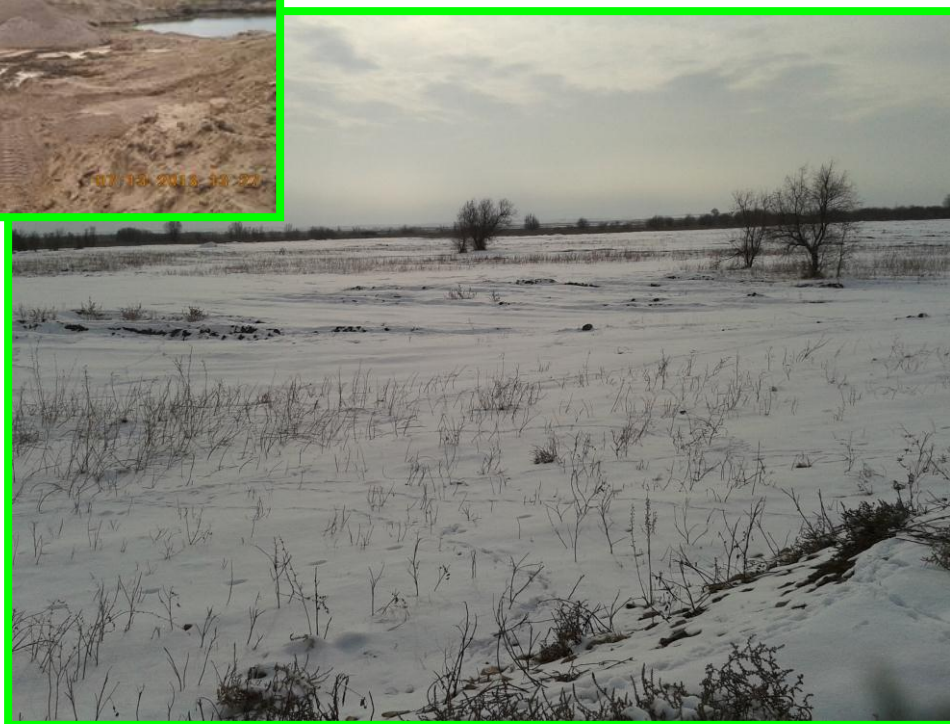
Photo No. 10 : Borrow pit near km 261

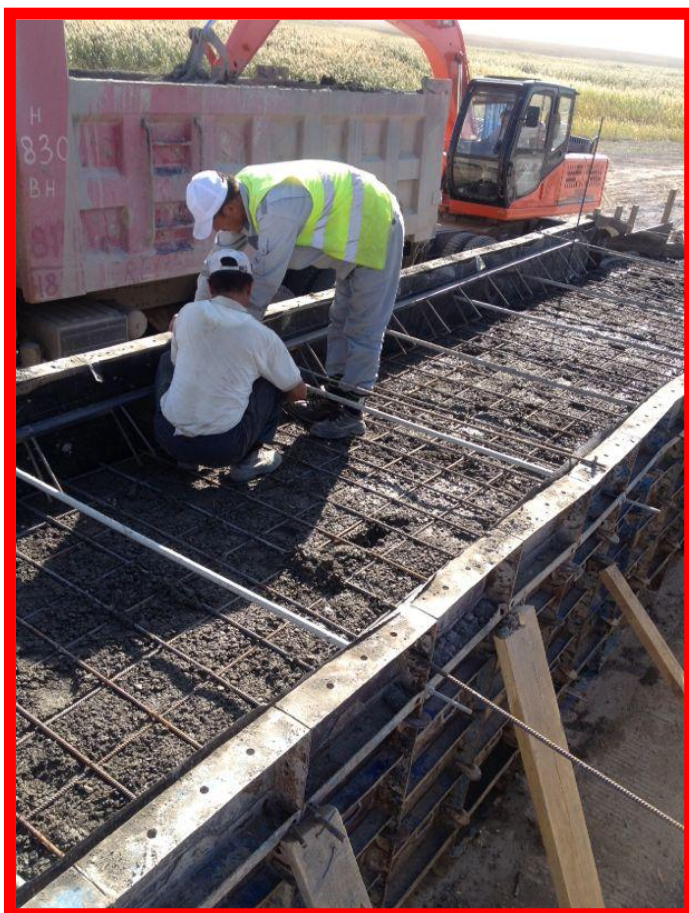
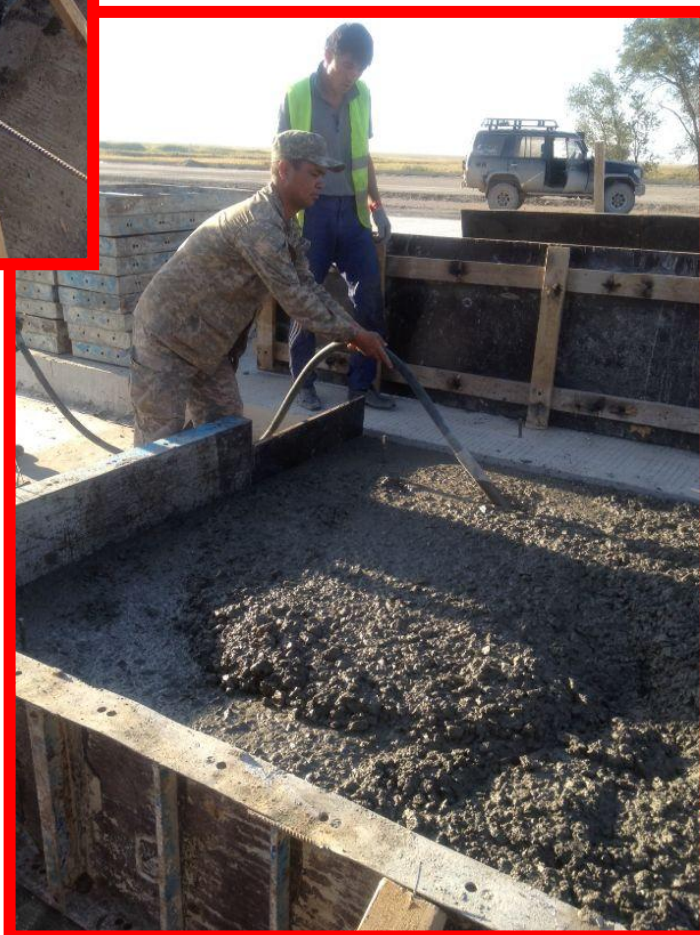
11	<u>Workers not wearing protective work clothes</u> – At the worksite, workers are not wearing the required protective clothing. [Photo No. 11].	Workers should at all times wear their protective clothing and should be checked by immediate supervisor at all times	Contractor to instruct their workers to wear protective clothing. Engineer to inspect and monitor	Immediately

Photo No. 11 : Workers not wearing required protective clothing
