CONSTRUCTION SUPERVISION OF THE ASPARA-BLAGOVESHENKA  
SECTION IN ZHAMBYL OBLAST, INVESTMENT PROGRAM PROJECT4  
(ADB Loan # L2735-KAZ, CAREC Transport Corridor I)

# THREE-MONTH ENVIRONMENTAL MONITORING REPORT - DECEMBER 2012

Project Number: 41121-053  
{December 2012}

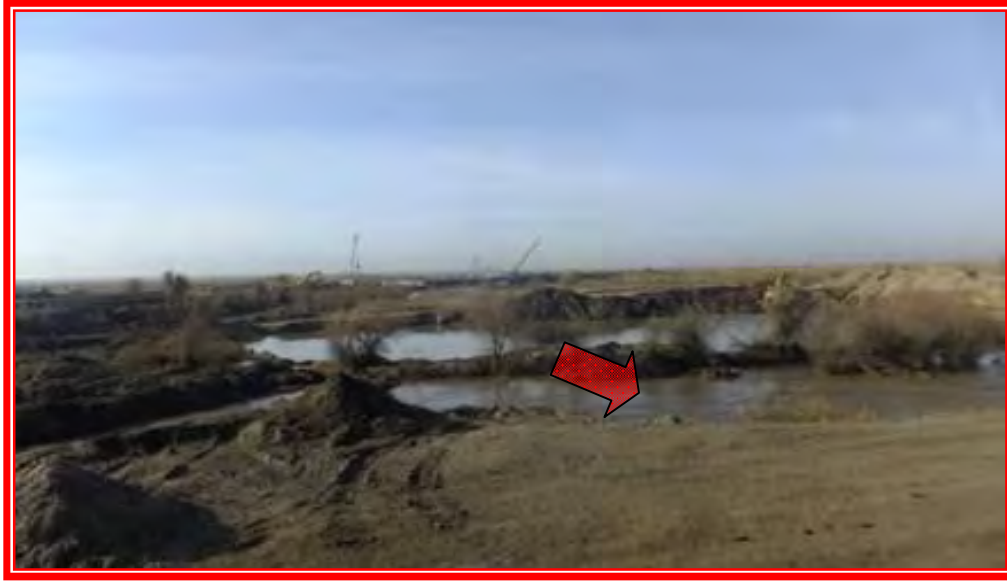
**Photo No. 1 : Pond's silt holding capacity near spilling condition**

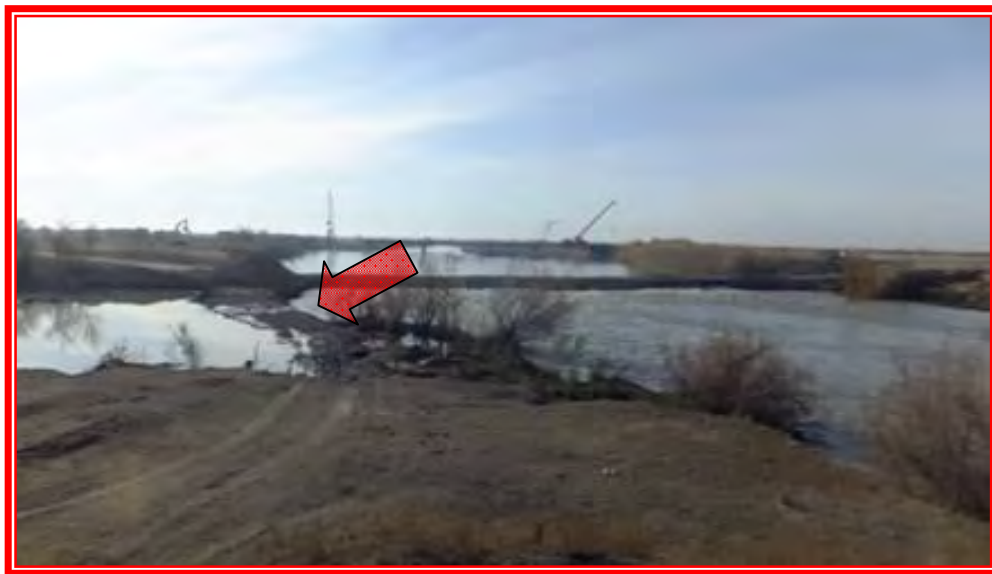
**Photo No. 2 : Filter berm is too low and needs to be increased in height**

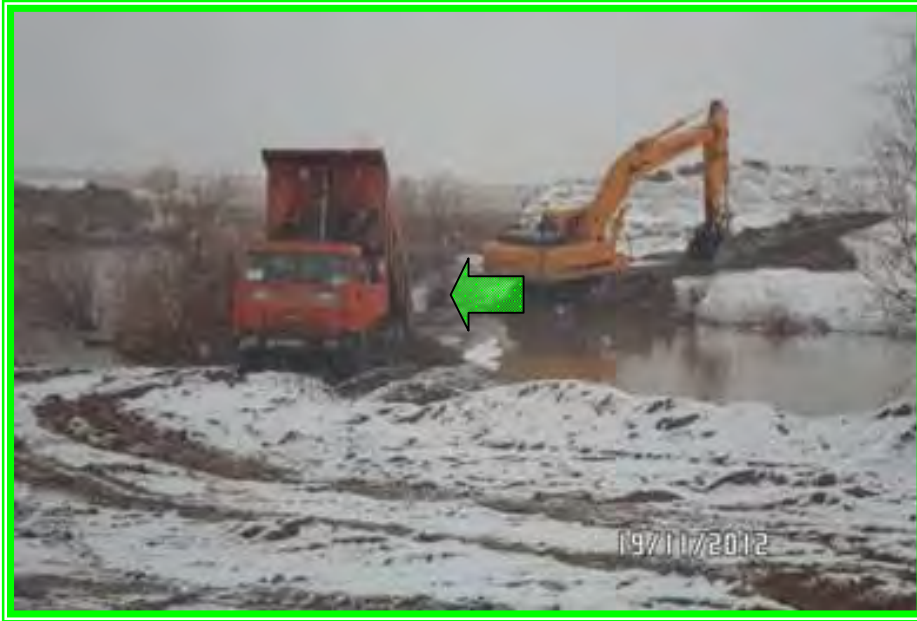
**Photo No. 3 : Contractor starting to increase the elevation of filter berm**

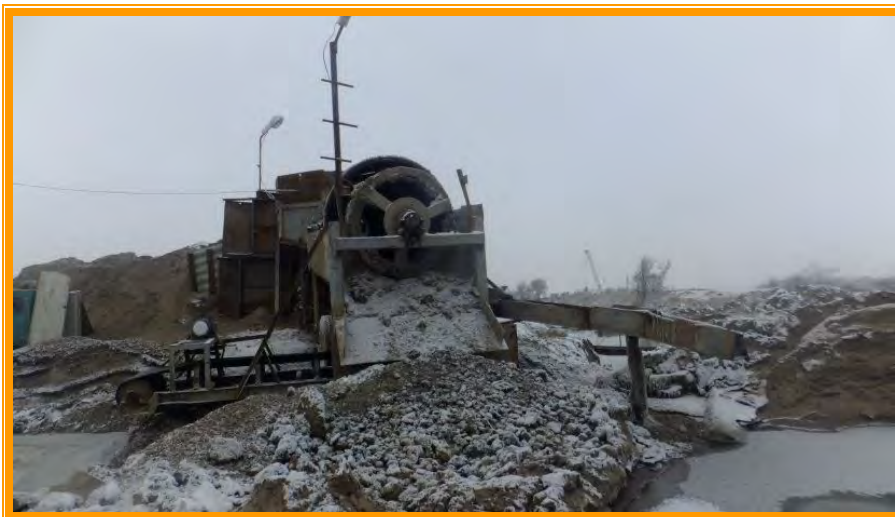
**Photo No. 4 : Suspension of material washing work due to bad weather**

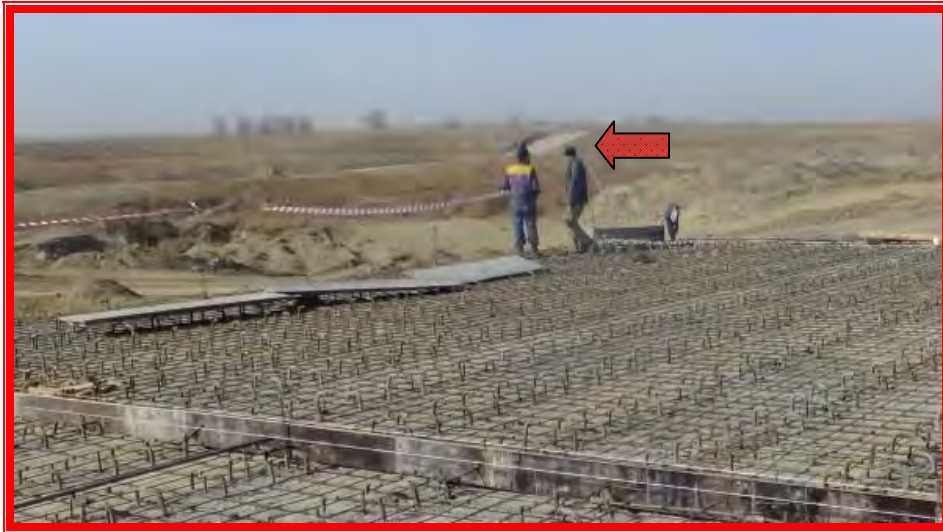
2	<u>Workers' Safety Issue<sup>8</sup> at Bridge Construction Sites</u> – (1) Workers were not wearing helmets (Photo No. 5); (2) One worker was wearing rubber shoes instead of prescribed working boots (Photo No 6).	<u>Necessary Response from the Contractor:</u> (i) the Contractor should instruct every worker at the site to wear the prescribed helmets and work boots; (ii) the Contractor should report compliance as soon as possible	For compliance by the Contractor	Information on provision of PPE will be submitted on November 27, 2012. (Health & Safety Officer was on leave)
3	<u>Improper Solid Waste Management at the Subcontractor's Site</u> – Rubbish scattered at the Campsite of the Subcontractor (Photo No. 7); Also contamination at the Subcontractor's Camp (Photo No. 8)	The Contractor should regularly inspect sites of subcontractors and instruct them to comply with EMP and all prevailing regulations	For compliance by the Contractor	This issue was discussed directly with the Subcontractor "MO-1" LLP

**Photo No. 5 : Workers not wearing helmets**

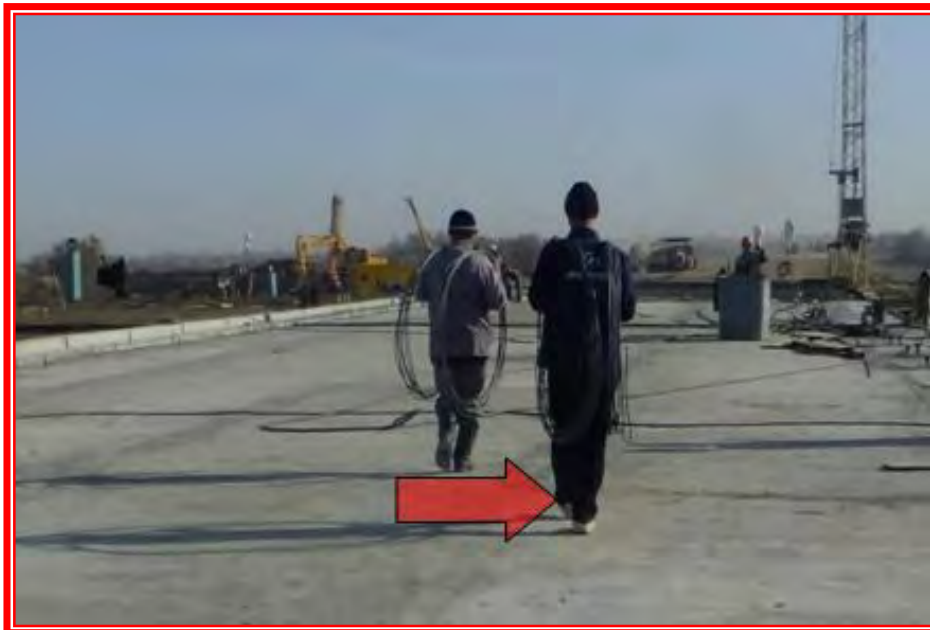
**Photo No. 6 : Improper protection by wearing rubber shoes in the work site**

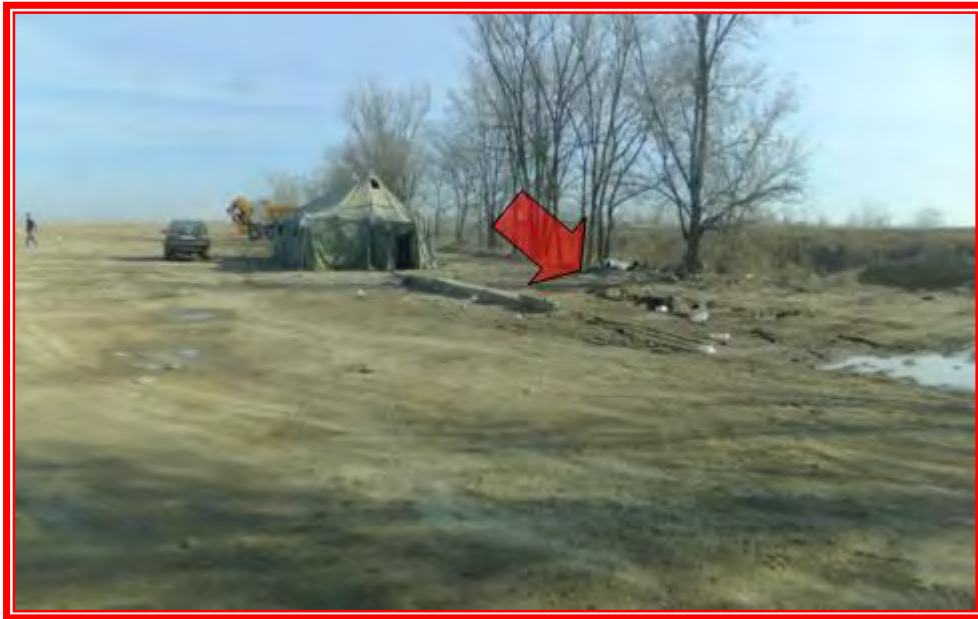
**Photo No. 7 : Improper solid waste management**

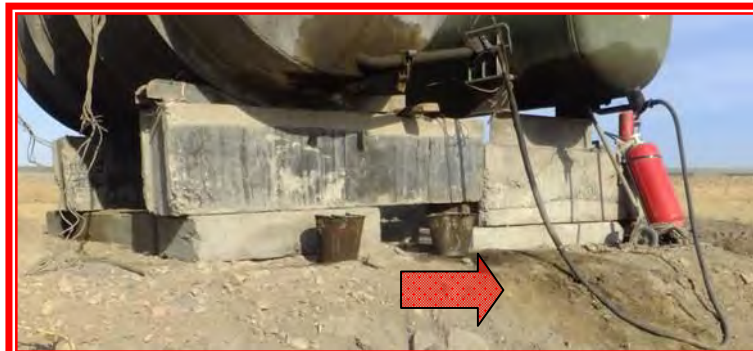
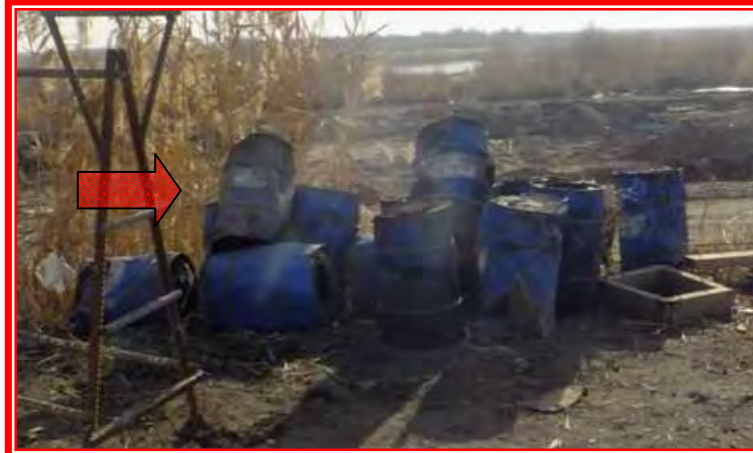
**Photo No. 8 : Improper hazardous waste management (spills and drums) at bridge no. 1 Subcontractor camp**

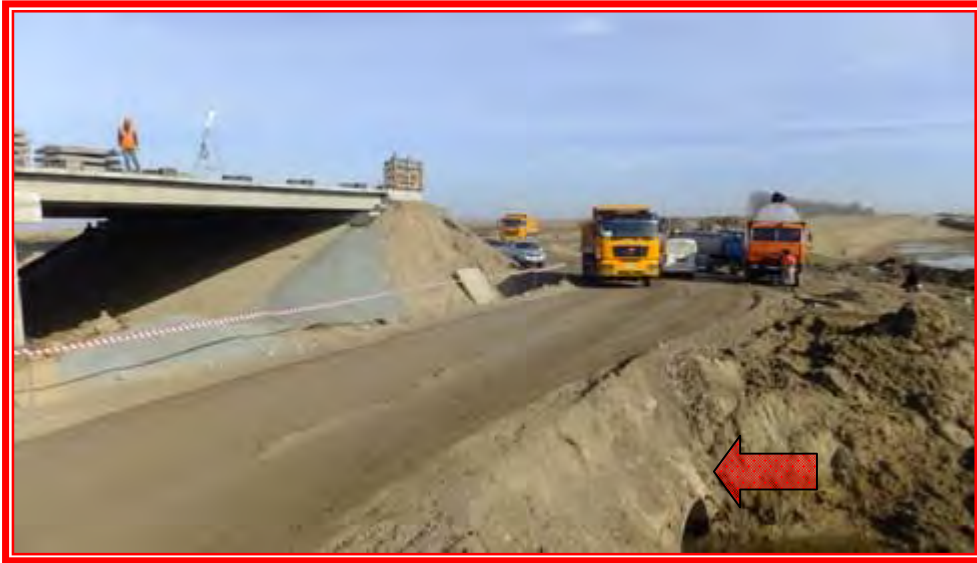
**Photo No. 9 : Too narrow diversion crossing at bridge no. 2**

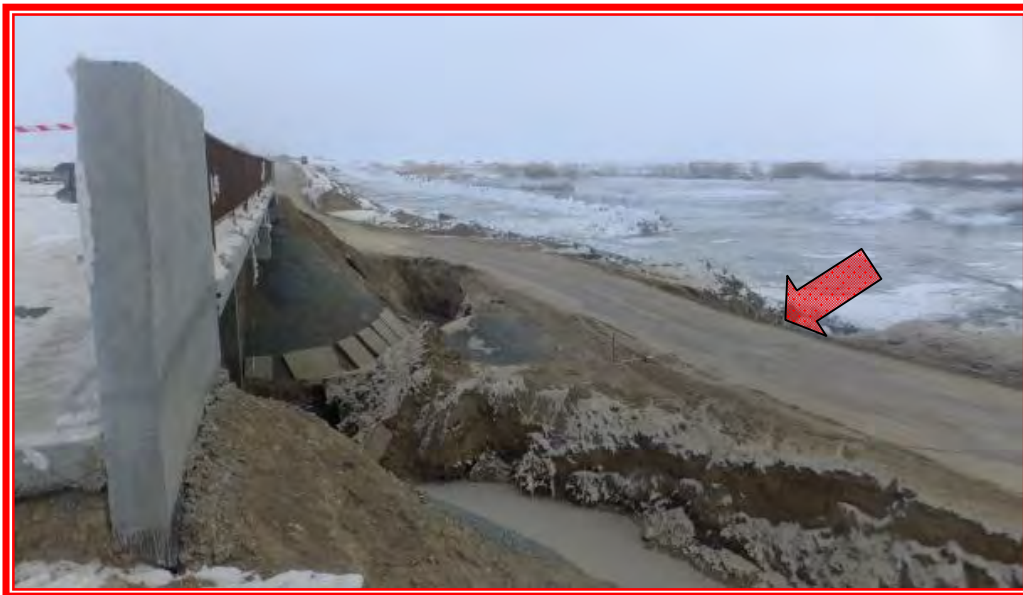
**Photo No. 10 : Still the same condition of the narrow crossing at bridge no. 2**

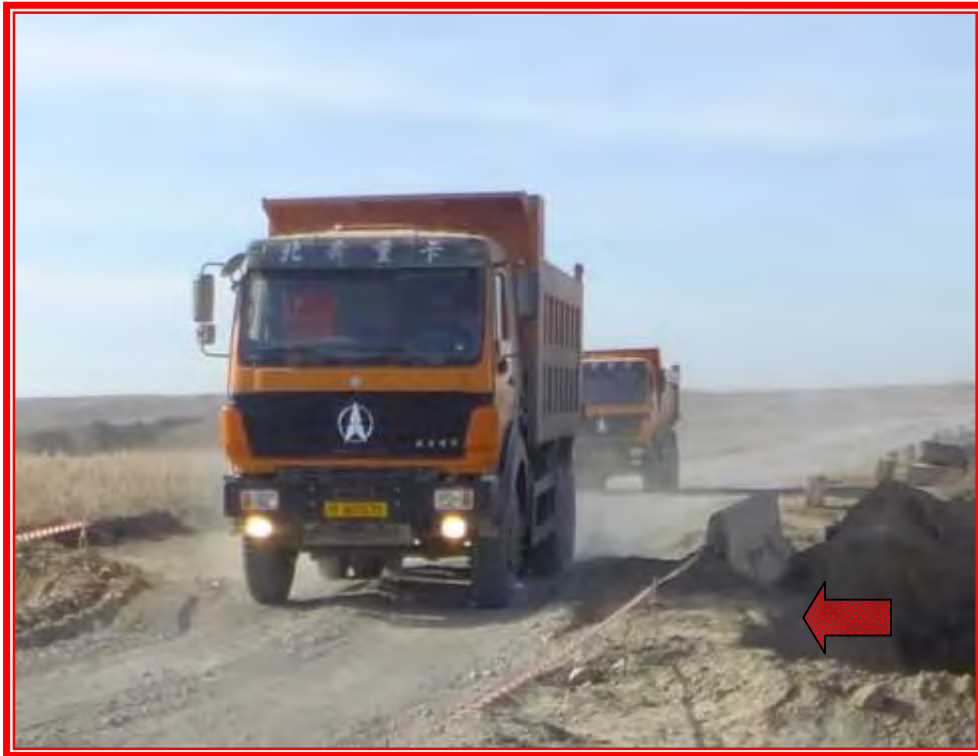
**Photo No. 11 : Narrow crossing at bridge no. 3**

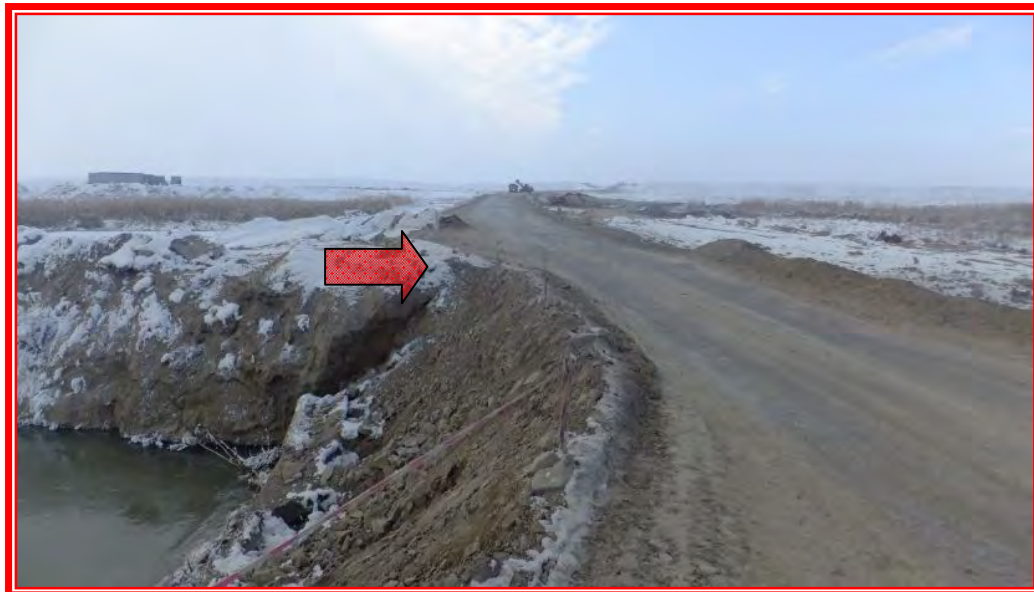
**Photo No. 12 : Unchanged situation at bridge no. 3**

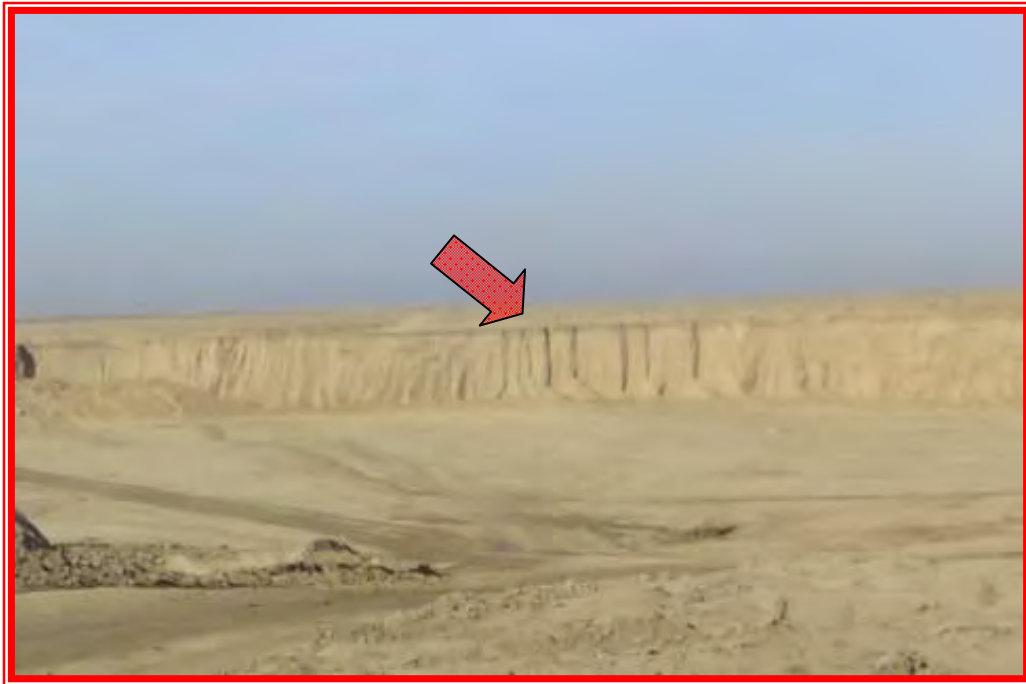
**Photo No. 13 : Vertical Cuts at borrow pit at km 269+500**

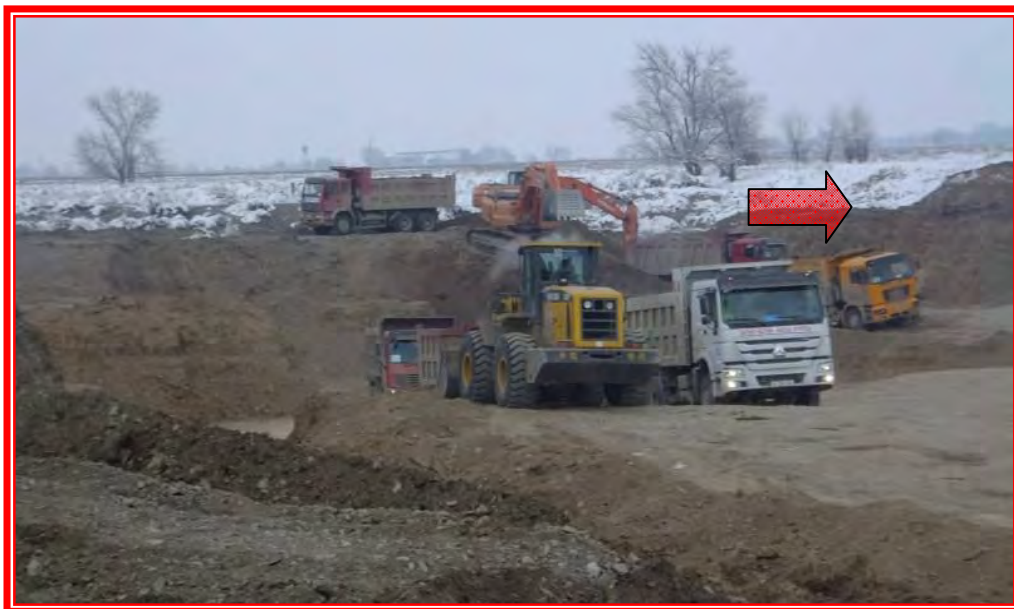
**Photo No. 14 : Recent situation of the borrow pit at km 269+500**

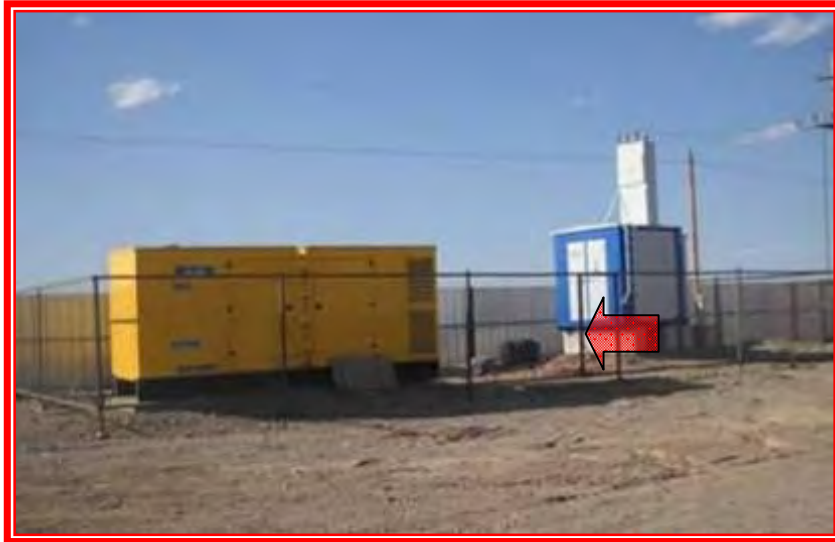
**Photo No. 15 : Absence of delineation for safety and absence of warning sign**

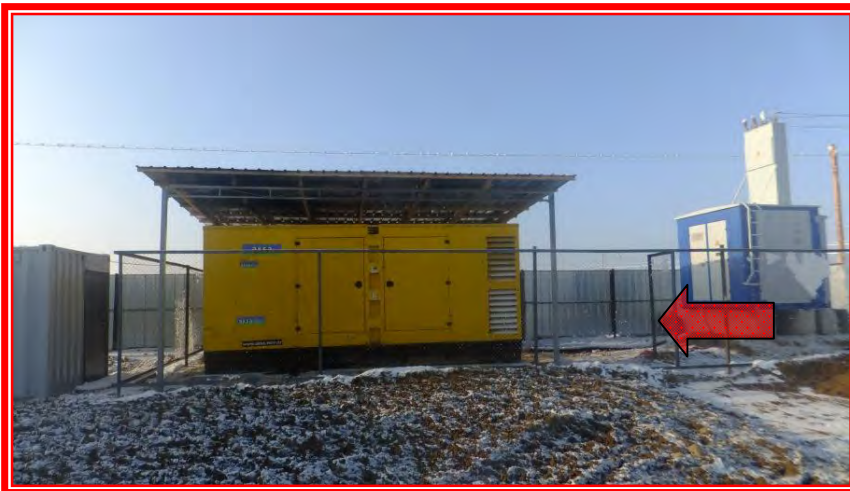
**Photo No. 16 : Similar situation prevailed (no safety delineation and signs) in previous inspection**
