Semi-annual environmental monitoring report

Project number: No.3416-KAZ
Reporting period: January - June 2020

REPUBLIC OF KAZAKHSTAN: CAREC Corridors 1 and 6 Connector Road (Aktobe-Makat) Reconstruction Project (section km 330-504)

Prepared by Dongsung Engineering Co., Ltd in association with subconsultant ZS Engineering for the Ministry of industry and infrastructural development of the Republic of Kazakhstan and the Asian Development Bank.

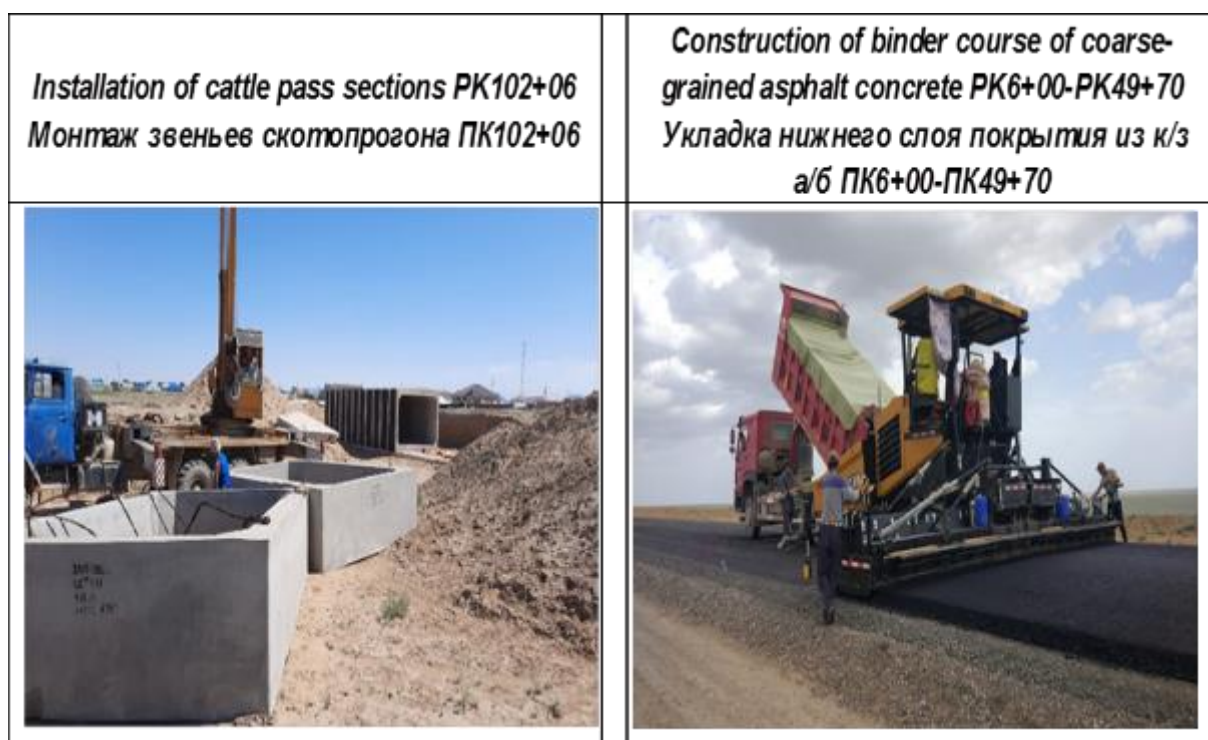
Picture 3. Road works on Lot 4: animal crossing construction and pavement works 14.06.2020

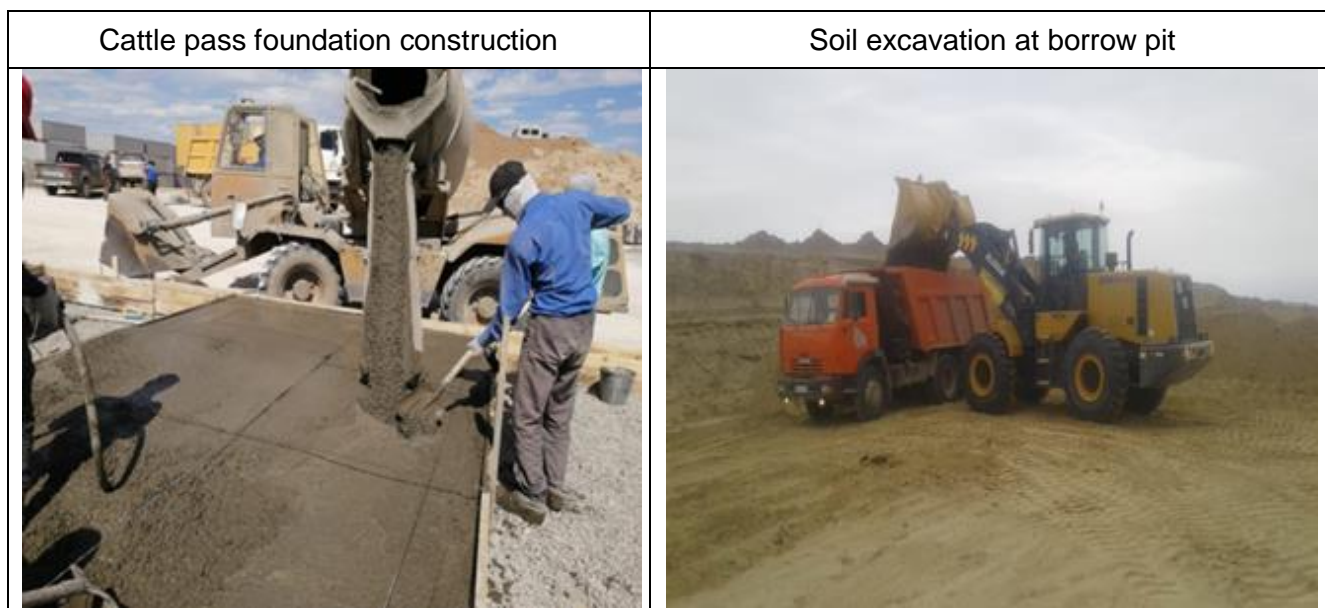
Picture 4. Lot 5 road works: foundation and excavation works, 20.06.2020

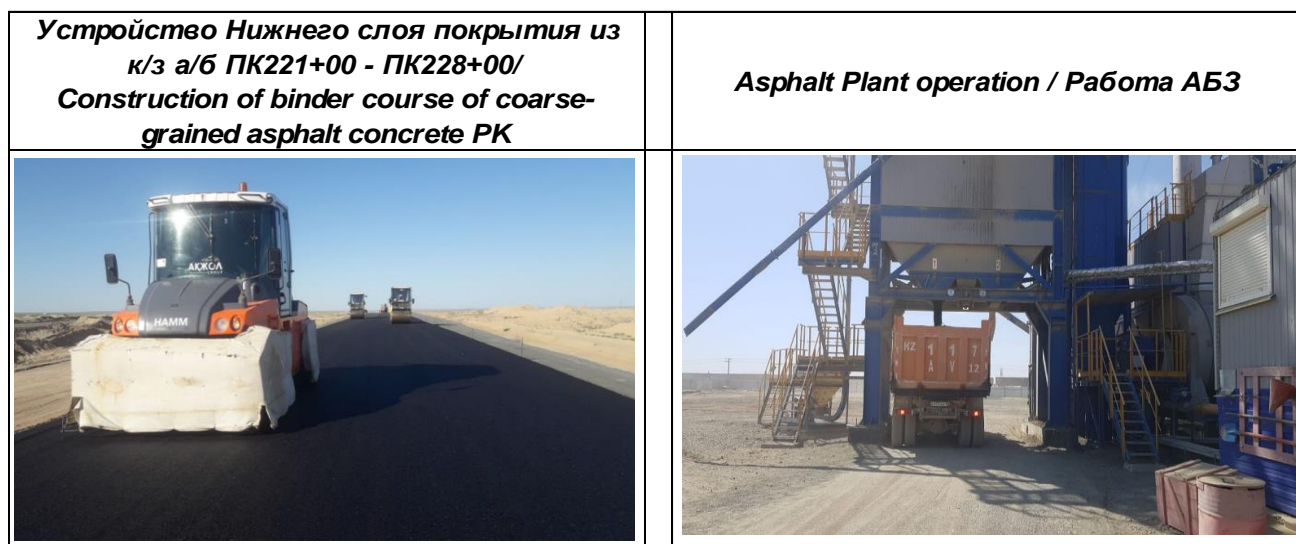
Picture 5. Lot 6 road works: asphalt laying, operation of Asphalt plant, 08.06.2020

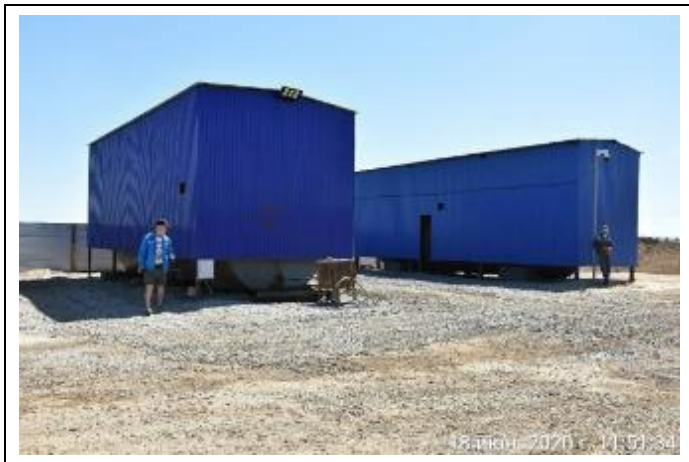
During the virtual mission by the request of ADB consultant, photo and information were submitted about arranging a tank as temporary storage of fuel and lubricant materials within base camp territory according to the EMP requirements of Lot 4

Picture 6. Temporary storage of fuel and lubricant materials within base camp territory, Lot 4. May 2020

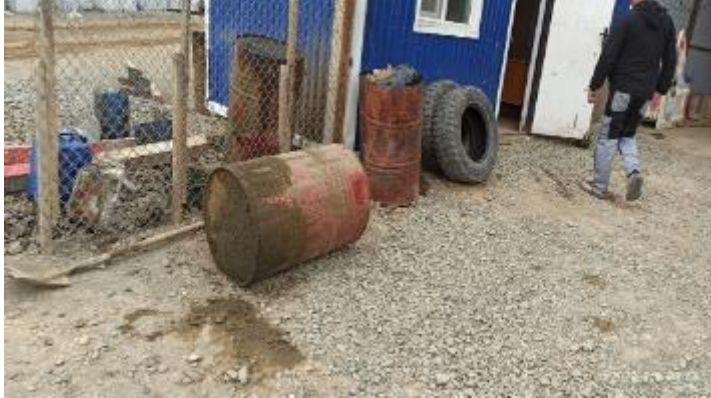
No.	Issues of concern	Site / LOT/ PHOTO Responsible	Recommendations to take measures	Results of site EM with regard to identified non- conformances
1	<p>The construction camp was polluted by waste and workshop area was contaminated by FLM</p>

Project Manager Environmental specialist LOT 4	To arrange a place for temporary storage of production waste on the workshop area according to the EMP, to clean up the territory, to clean fuel filling	EM has not been carried out

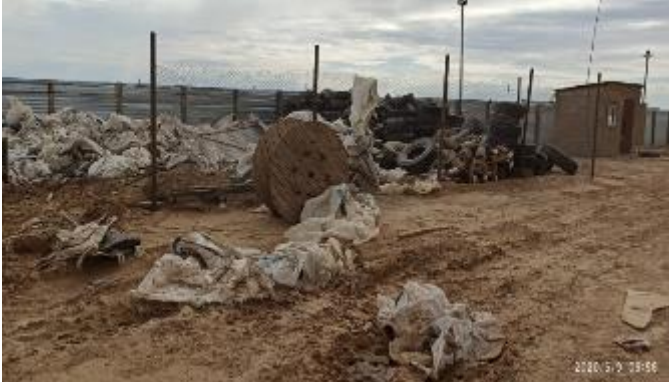
2	<p>There were other types of waste on the temporary storage area of used tires on base camp</p>

<p>Project Manager Environmental specialist LOT 4</p>	<p>To clean temporary storage area of used tires from other types of waste and to remove the accumulated waste according to the agreement in order to reduce the environmental impact</p>	<p>EM has not been carried out</p>
3	<p>There was waste water filling from the septic tank on soil cover behind of base camp fencing, due to untimely removal of waste water</p>	<p>Project Manager Environmental specialist LOT 5</p>	<p>To eliminate urgently waste water filling from the septic tank according to the SSEMP. To clean up the contaminated area. To control the fill level of the septic tank and to organize timely the removal of waste water</p>	<p>Executed</p>
3

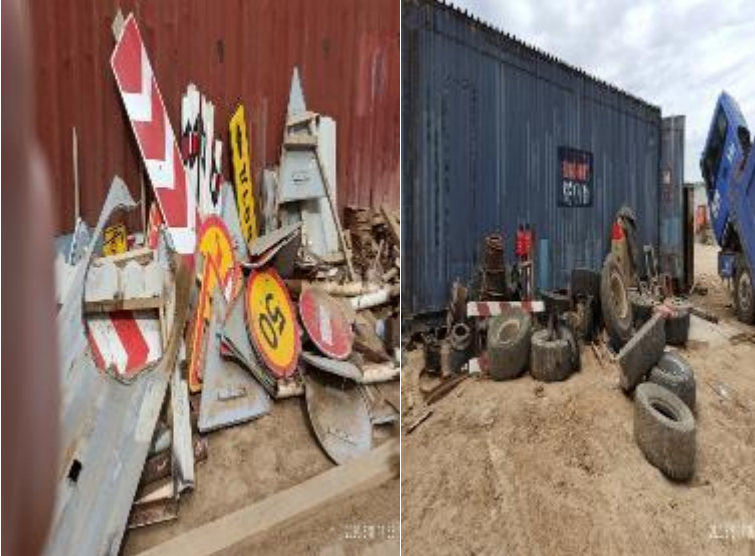
4	<p>Base camp pollution by waste, tires. Equipment repair on the unorganized area</p>	<p>Project Manager Environmental specialist LOT 5</p>	<p>All types of waste are stored in designated areas in metal containers with marking.</p>	<p>Executed</p>

<p>Containers are installed on special reinforced concrete platforms. To arrange a place for temporary storage of production waste according to the EMP. To remove and dispose the accumulated waste according to the EMP</p>

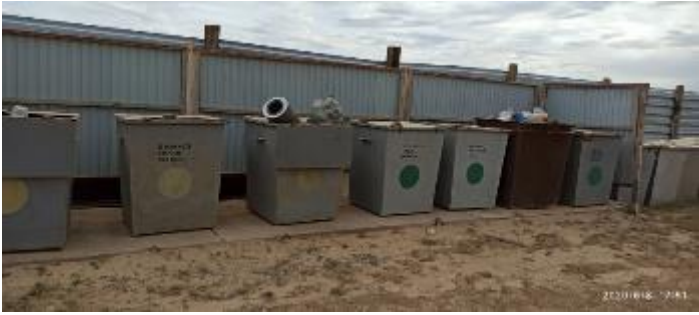
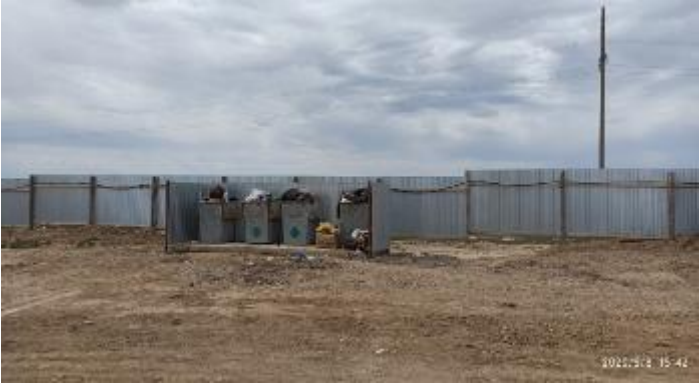
5	Untimely waste removal, overflow of containers and waste segregation, waste placement in contradiction with its marking	Project Manager Environmental specialist LOT 5, 6	To organize a training for employees about waste placement and segregation.	
<p style="text-align: center;">Lot 5</p>

<p>To conduct Saturday clean-up work, to clean up the territory.</p> <p>To store waste and to dispose it timely in accordance with the EMP and the service agreement.</p>	<p>Executed</p>

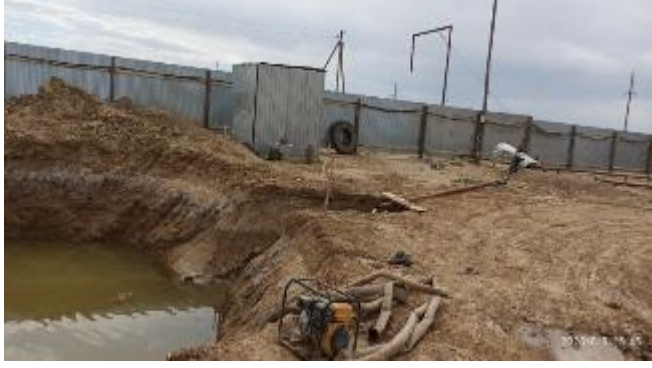
6	There is the accumulation of rainwater (pit) on base camp territory for the further use for dust control	Project Manager Environmental specialist LOT 6	To arrange in accordance with the EC RK and to install a tank with volume 20-50 m3, to install a fence	Measures are being taken

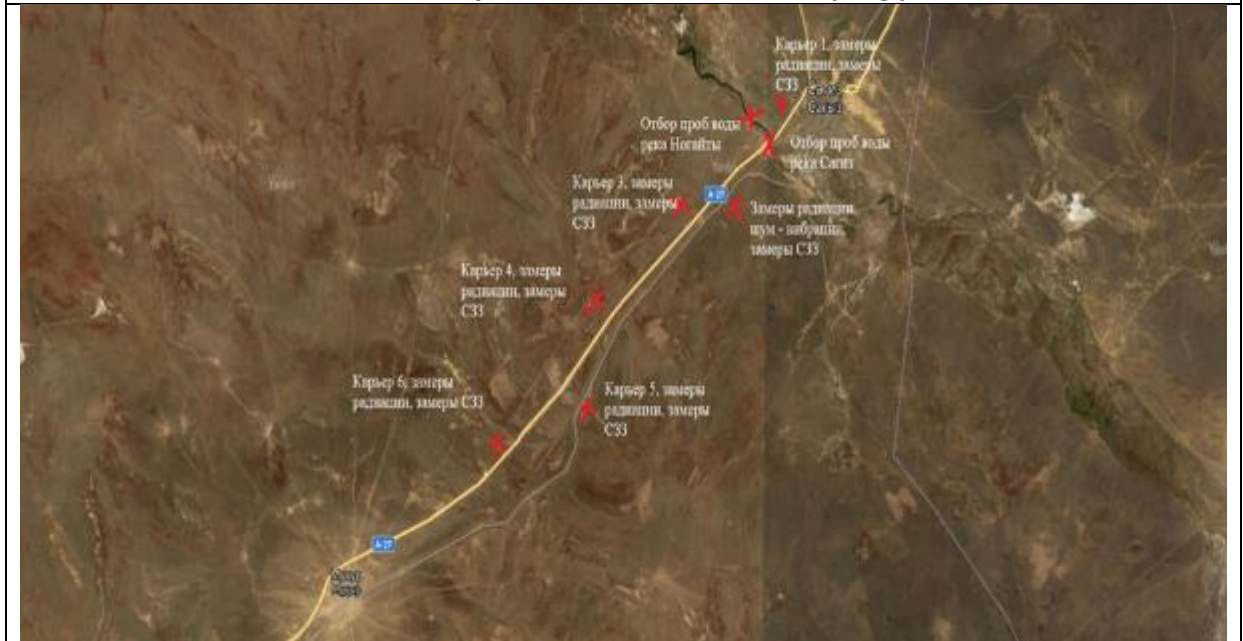
Picture 4.1 – Location of air, noise and vibration sampling points LOT 4

71. Monitoring was carried out at the points specified in the Contractor's SSEMP, see the picture 4.1. Due to the absence of environmental specialist on the project until September 2019, the first monitoring was conducted on September 25, 2019, which will be the baseline monitoring. According to submitted sampling reports and their results, during sampling were recorded atmospheric air, climatic parameters: wind speed, direction, barometric pressure, humidity, temperature. Measurements on Lot 4 were made by the following indicators: inorganic dust (suspended particles), nitrogen oxide, nitrogen dioxide, sulfur dioxide, carbon monoxide, formaldehyde, hydrocarbons C12-C19 and hydrogen sulfide.

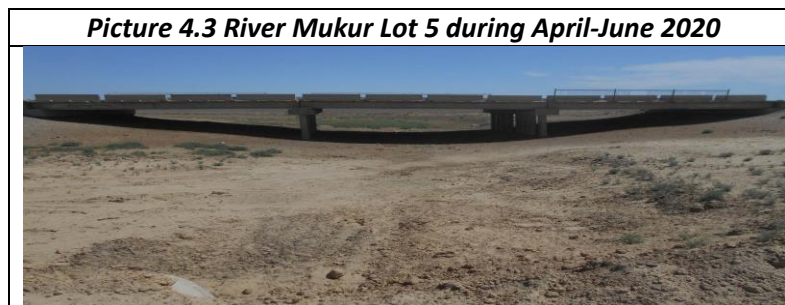
88. Temporary watercourses occur only during heavy rain or heavy snow melt within the project works territory of Lot 5. Surface water resources are only the flow of river Mukur coming from Aktobe region, also local flow of small temporary watercourses and small rivers of the second and third type. Mukur river does not have a permanent flow for 11 months throughout the area (about 20 km). In summer the river dries up completely. An agreement No 211/3/AZHК dated 04.07.2019 was concluded with “EcoNormative” LLP for quarterly IEM.

Picture 4.3 River Mukur Lot 5 during April-June 2020

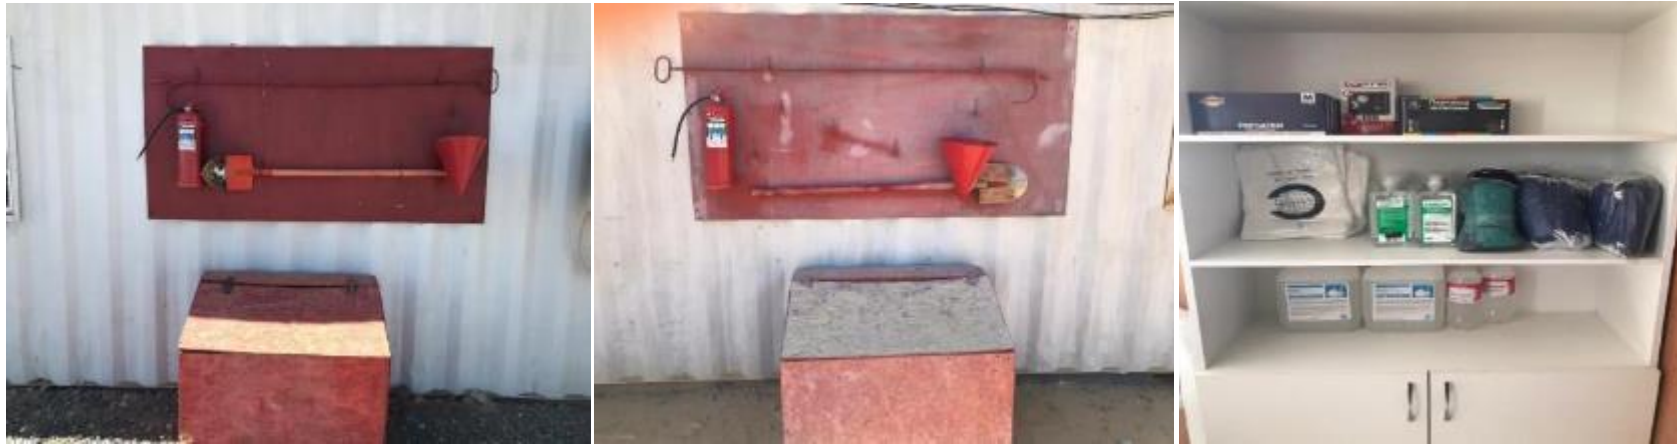
Appendix for Health and Safety part. PHOTO: Fire safety board. Protective things within the construction camp, Lot 6

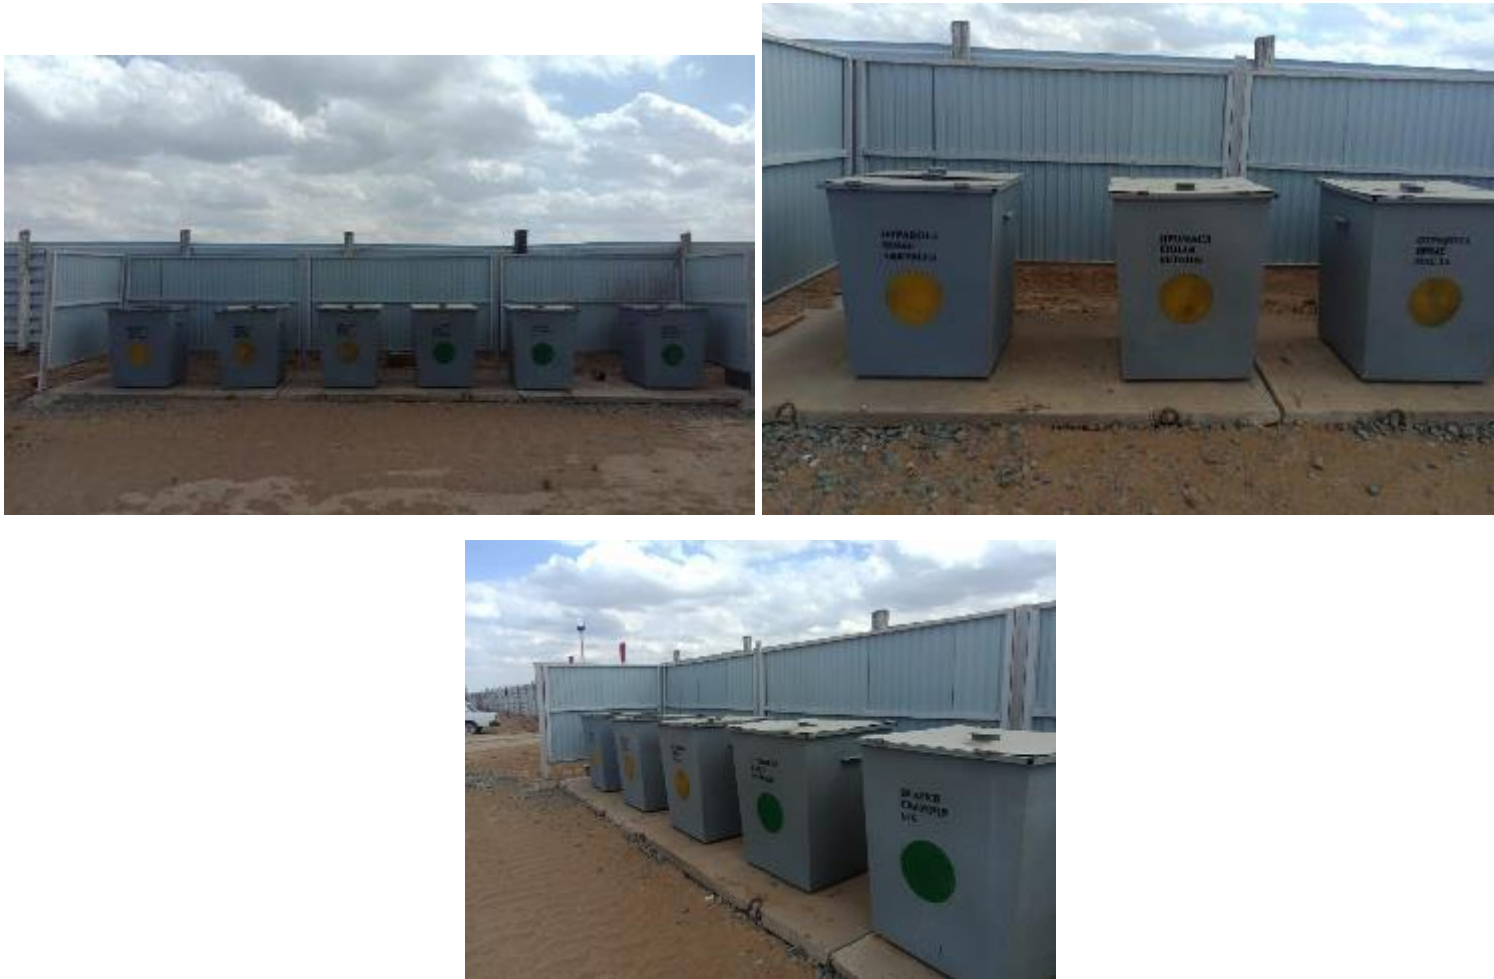
Waste containers within the construction camp, Lot 5

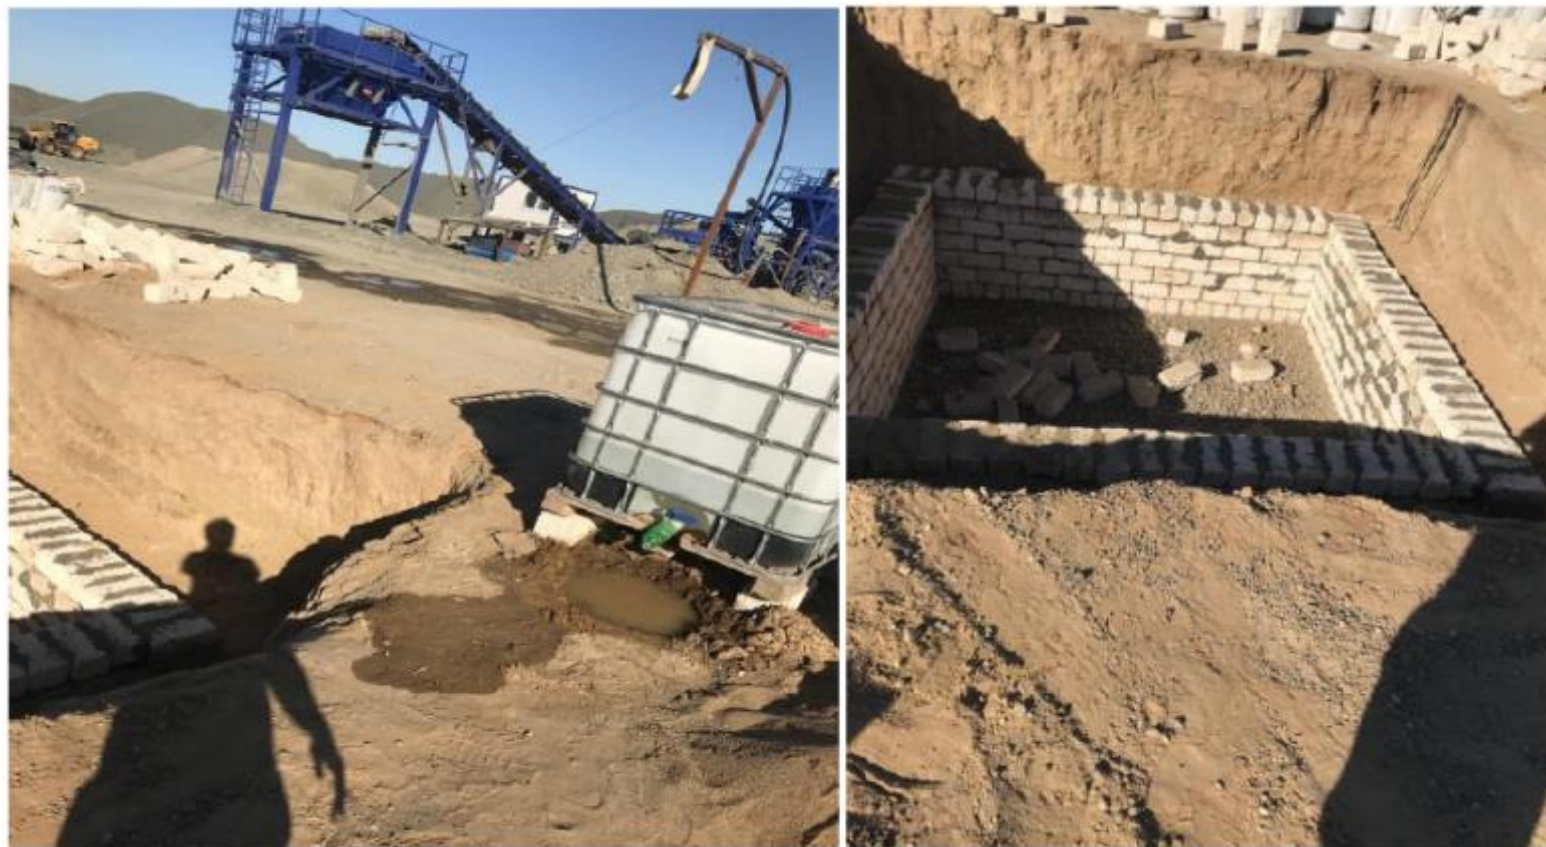
Lot 4 Construction of Storage Tank for Artesian Water, collecting at night time, for water trucks, dust control
